Home Inspection

Summary Report

Inspection Address: 123 Home Inspection Way, Anytown, AZ 85111

Inspection Date: 3/22/2018 Start: 2:00 pm End: 4:00 pm

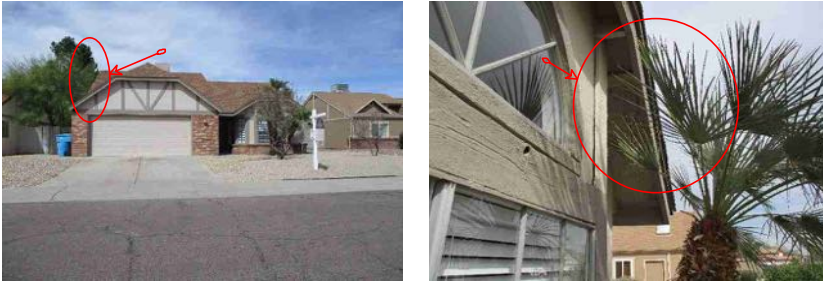
2.2 - A tree limbs are threatening the roof and eaves, and should be trimmed or removed before it damages the roof or eaves.

Tree - threatening roof and eaves - *Continued*

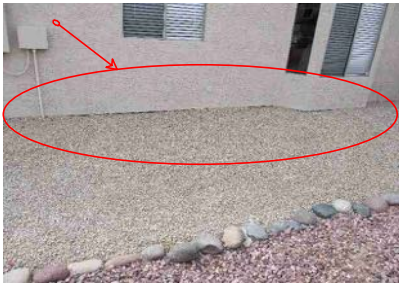
- 2.3 - In some areas the landscaping material is near or up to the weep screed. This condition is not desirable because it conceals the stem wall and helps pest infiltrate the walls. Ideally there should be 4" - 6" of clear space below the weep screed.
- East side yard.

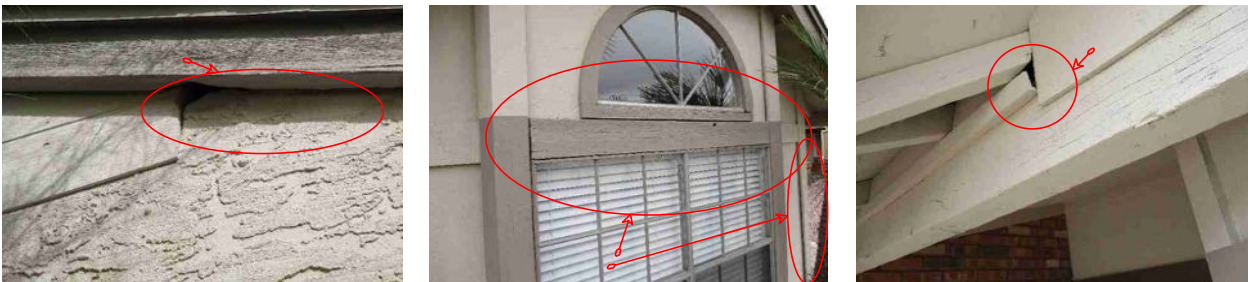
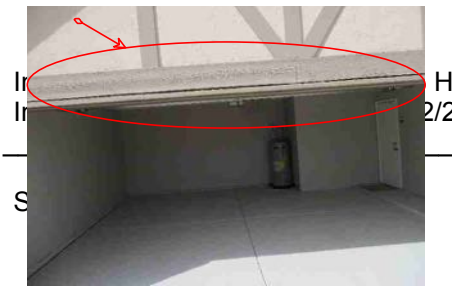
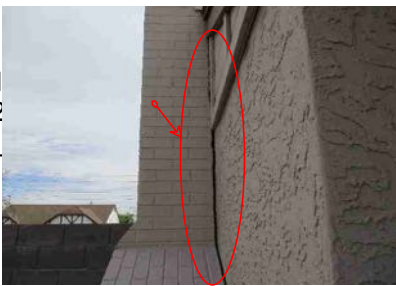
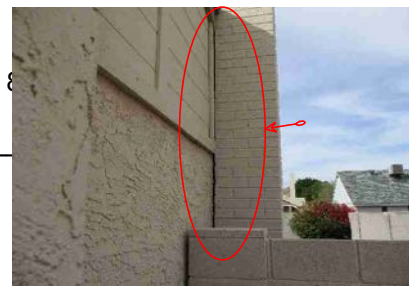
- 2.4 - Check and seal penetrations, gaps and dings at the exterior walls including the transition areas at the window/ door surrounds as needed to prevent moisture and or pest intrusion.
- Multiple gaps and trim/fascia that should be serviced.
 - Trim boards at the south side, windows and garage should be sealed
 - Large gaps at chimney should be sealed.

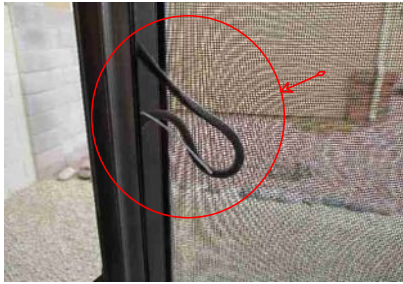
- 2.8 - A window will need service to work well.
- Windows that do not slide properly are the kitchen and family room east windows. Weather stripping damaged at east family room window.
- The down stairs bathroom west window does not lock.

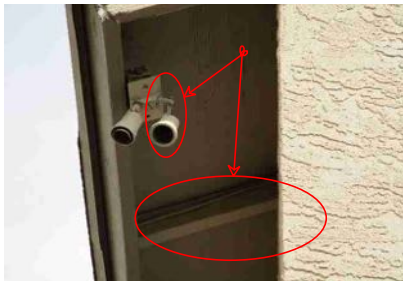
- 2.9 - Electrical Conditions:
There are exposed electrical conductors. Current industry standards require that exterior conductors be placed in a protective conduit and you may wish to have further evaluated and serviced as necessary.
- Rear flood light.

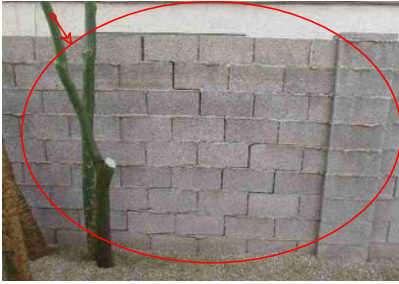
- 2.10 - The west yard walls can be easily moved and should be evaluated by a masonry contractor.

Easily moved - evaluate - *Continued*

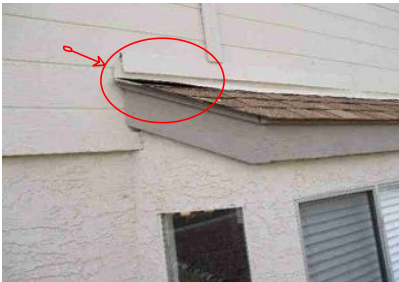
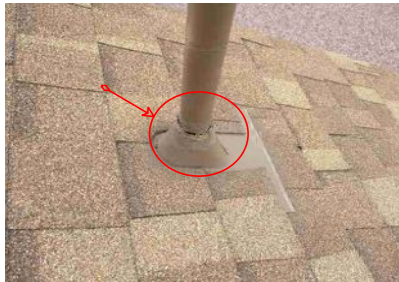
3.1 - The roof flashings need to be sealed or serviced. They are comprised of metal that seals valleys and vents and other roof penetrations, and are the most common point of leaks. This is particularly true of the flashings on a layered roof, which are covered by the roofing material and which are even more susceptible to leaks.

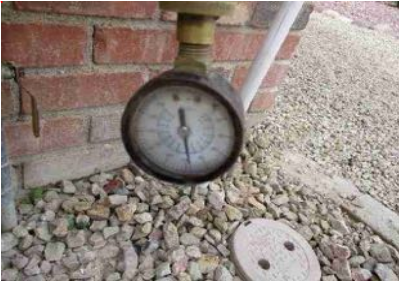
4.2 - The pressure at the distribution shut off exceeds 80 psi, (99 psi) which is too strong and will stress components of the system. Pressure readings can fluctuate throughout the day and a regulator may not be needed. We recommend that the pressure be checked at different times to get a more accurate reading. If the pressure is consistently over 80 PSI we recommend that a regulator be installed. Most regulators come factory pre-set at 60 psi.

Regulator - Must be installed - *Continued*

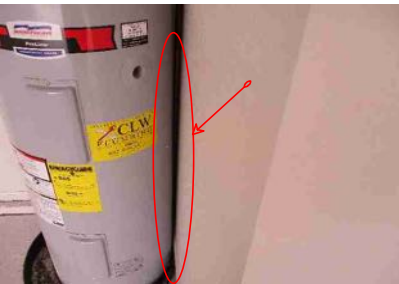
4.5 - The discharge pipe from the pressure relief valve is recommended to be plumbed to the exterior and terminate no more than twenty-four inches above grade and no closer than six inches to it.
- Discharges behind water heater into drip pan.

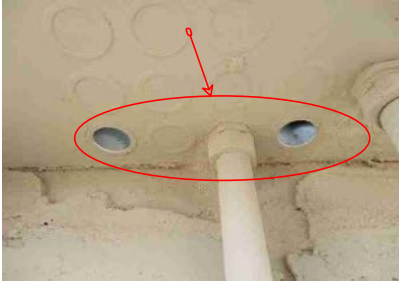
5.1 - The exterior cover panel has voids or open knockouts that should be covered.

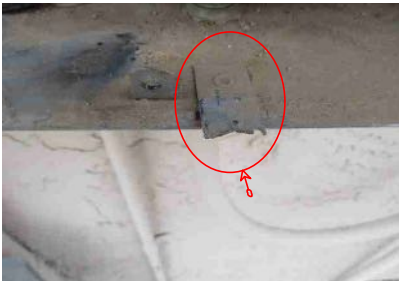
5.2 - The exterior panel cover latch is damaged, and should be serviced.

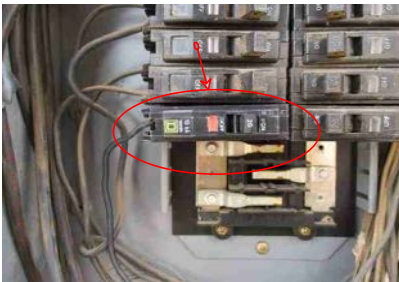
5.4 - One circuit breaker is tripped and cannot be reset, which means that the breaker is defective or that there is an in-line short, which should be determined and corrected by an electrician.
- 20 amp labeled "rear flood".

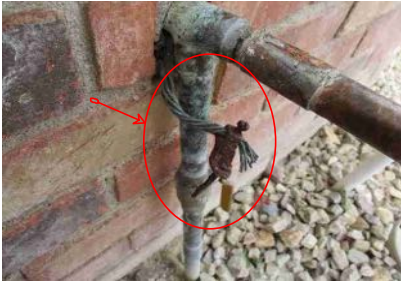
5.5 - The panel-ground to a water pipe, is detached and should be reattached by an electrician.

Ground - Detached - Water Pipe - *Continued*

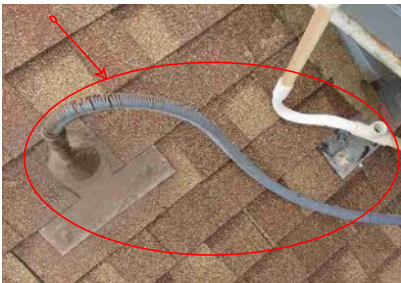
- Conduit has lost the weather proof coating and you may wish to have further evaluated by an electrician or HVAC specialist.

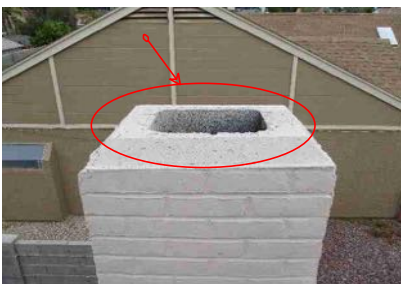
8.1 - The chimney does not have a weather cap/spark arrestor, which is recommended.

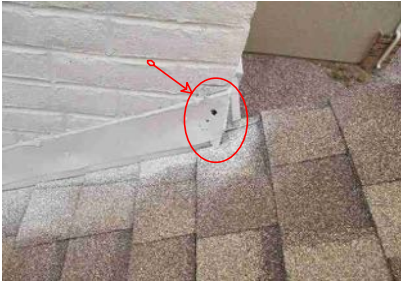
8.2 - The counter flashing between the chimney wall and the roof need to be resealed.

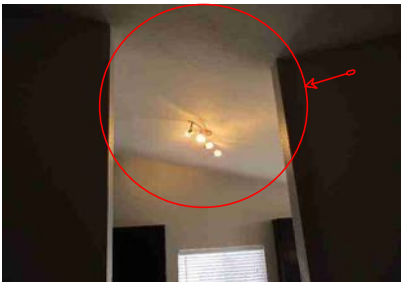
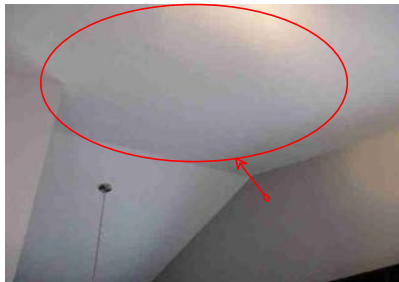
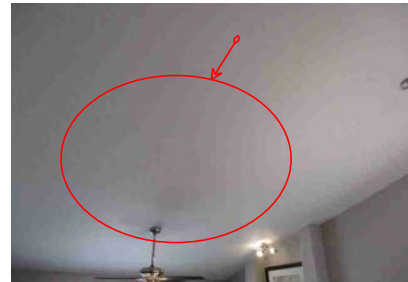
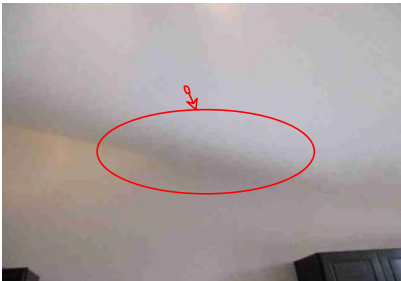
9.1 - Evidence of repairs to the ceiling where observed, you should ask the sellers about this or have further evaluated by a specialist.

- Downstairs bedroom front entry, kitchen and family room.

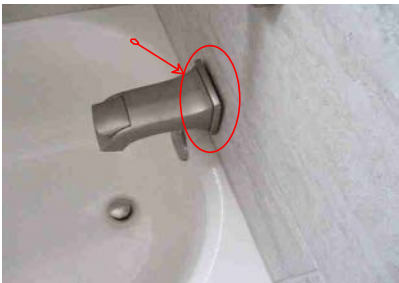
- Seal tub spout at wall to forestall moisture intrusion.

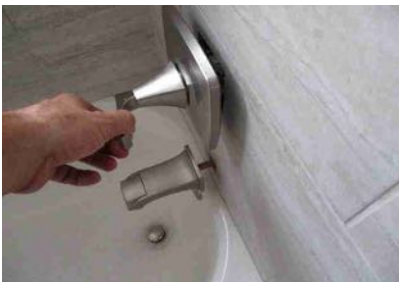
- The plumbing behind the tub shower is loose and should be serviced. The mixing valve and tub spout are loose and should be sealed once the loose plumbing is corrected.

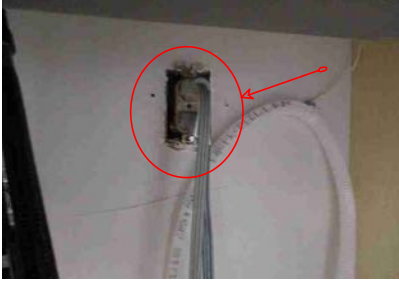
- 12.1 - None of the kitchen outlets serving the countertop have GFCI protection and upgrading is recommended. GFCI protection is mandated by current standards and is an important safety feature. GFCI protection may not have been required at time of construction, but we recommend as elective safety upgrade.
- 12.2 - A cover plate is damaged or missing and should be replaced.
- Under sink for garbage disposal.

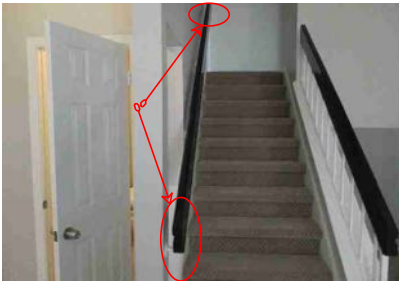
- 15.1 - The ends of handrails for stairs typically turn into the wall at each end so garments do not catch on the ends of handrail. This handrail is open at both ends and you may consider modifications or replacement, caution should be used until changes have been made.

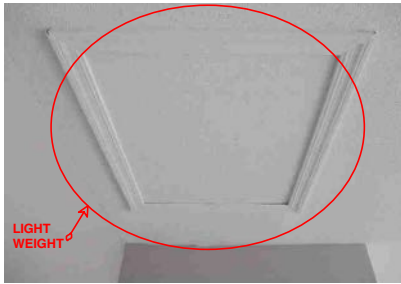
- 17.2 - The hatch cover to the attic area is made of a non combustibile material, however the cover is lightweight and should be weighted in order to provide a firewall separation between the garage and the residence.

Access cover - Lightweight - *Continued*

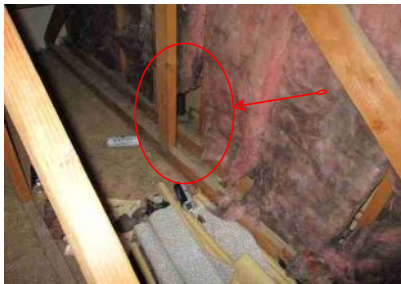
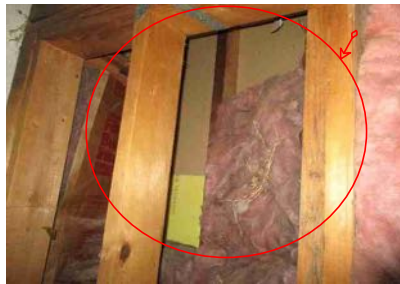
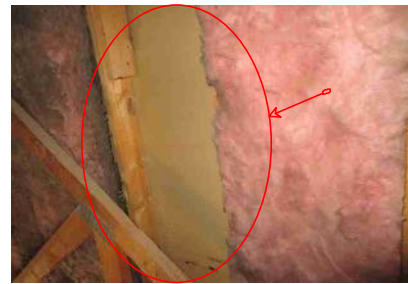
18.2 - There are voids in the insulation that should be serviced.
