# PCI Home Inspections LLC

## SUMMARY REPORT

**Inspection Address:** 123 Home Inspection Way, Anytown, AZ 85111

**Inspection Date:** 3/22/2018 Start: 2:00 pm End: 4:00 pm

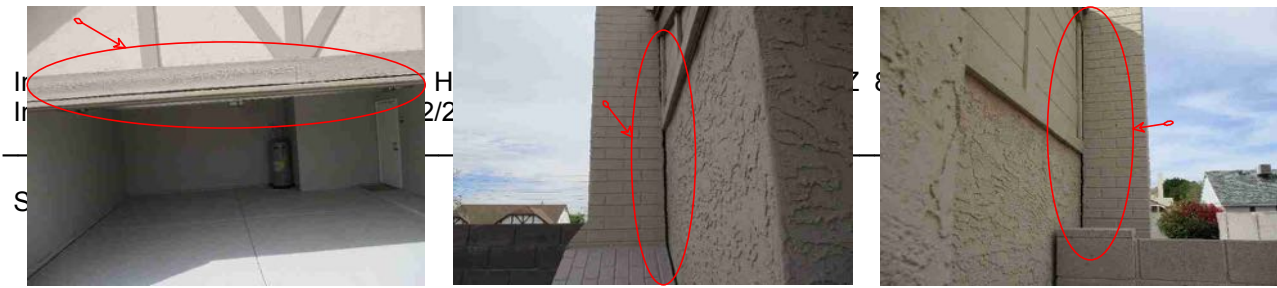
- 2.4 - Check and seal penetrations, gaps and dings at the exterior walls including the transition areas at the window/ door surrounds as needed to prevent moisture and or pest intrusion.
- Multiple gaps and trim/fascia that should be serviced.
  - Trim boards at the south side, windows and garage should be sealed
  - Large gaps at chimney should be sealed.

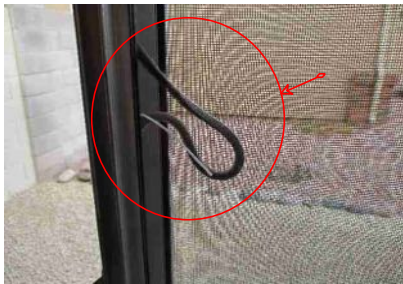
- 2.8 - A window will need service to work well.
  - Windows that do not slide properly are the kitchen and family room east windows. Weather stripping damaged at east family room window.
  - The down stairs bathroom west window does not lock.

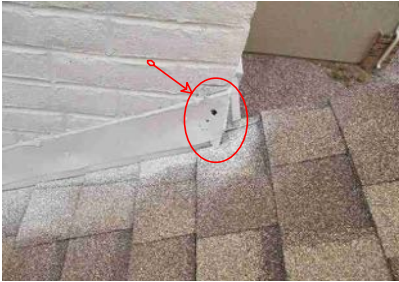
8.2 - The counter flashing between the chimney wall and the roof need to be resealed.

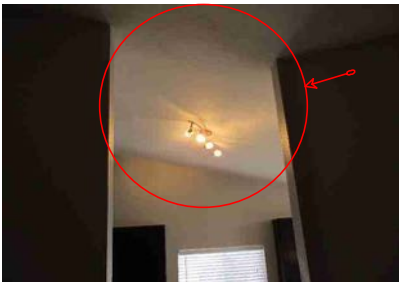
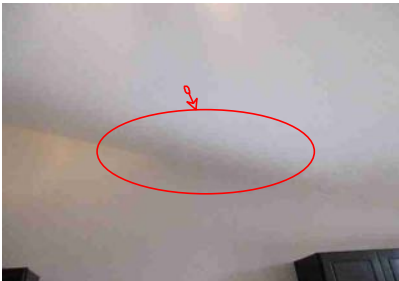
9.1 - Evidence of repairs to the ceiling where observed, you should ask the sellers about this or have further evaluated by a specialist.

- Downstairs bedroom front entry, kitchen and family room.
